Analysis of Damage Levels of Primary and Secondary Irrigation Channels in Suradadi Sub-district, Tegal Regency, Indonesia Based on Geographic Information Systems (GIS)

Valerina Aurellia Amanda^{1, a)}, Aditya Saputra^{1, b)}, Dedi Surachman^{2, c)}, Agus Anggoro Sigit^{1, d)}, Yuli Priyana^{1, e)}, Taryono Taryono^{1, f)}, Jumadi Jumadi^{1, g)}, M Iqbal Taufiqurrahman Sunariya^{1, h)}

¹*Faculty of Geography, Universitas Muhammadiyah Surakarta*

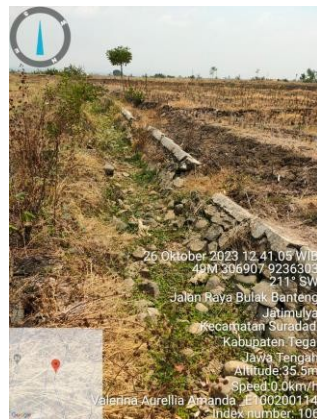
FIGURE 4. Irrigation Channels Heavily Damaged

Based on the documentation from Fig. 4 and Fig. 5 taken during the field validation process, it can be observed that there is quite a significant condition of damage to the irrigation channel which experienced heavy damage. The physical damage that occurred involved the collapse of most of the walls, large cracks, and structural damage that significantly hampered the flow of water in the irrigation channels. Meanwhile, for irrigation channels that experienced moderate damage, there were quite large cracks and structural damage to the walls, even though the basic structure of the channel was still there. Even though this damage is enough to hinder the flow of water, it still allows the flow to take place.

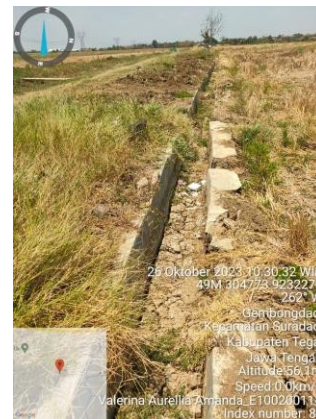
FIGURE 5. Irrigation Channels Are Moderately Damaged

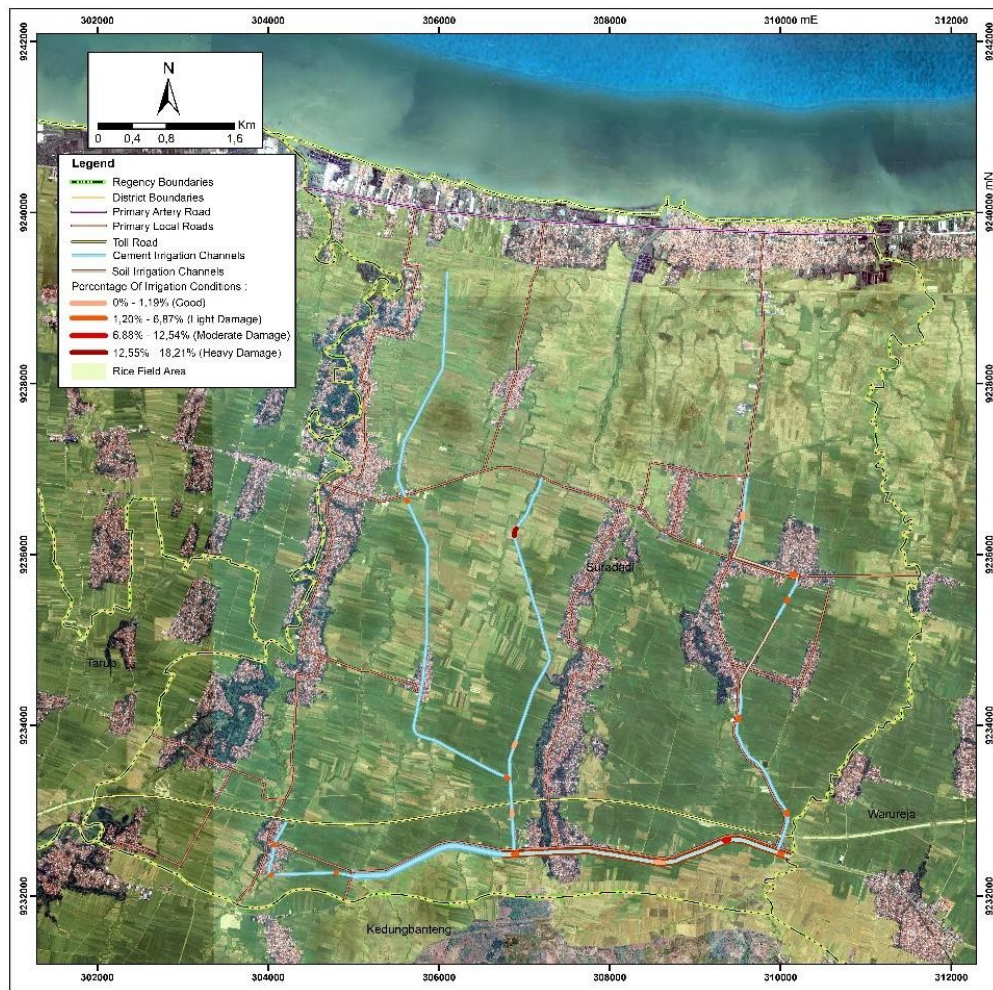
A more detailed visualization of the location of damage in Fig. 4 is presented through a map that clearly shows the location of damage to primary and secondary irrigation channels in the Suradadi Sub-district. This map not only shows the location of damage but also shows the percentage of damage by segment in primary and secondary irrigation channels. The information in this map provides a clear picture and makes it easier to recognize and respond to damage that occurs to primary and secondary irrigation channels in Suradadi Sub-district.

FIGURE 6. Map of Irrigation Channel Conditions

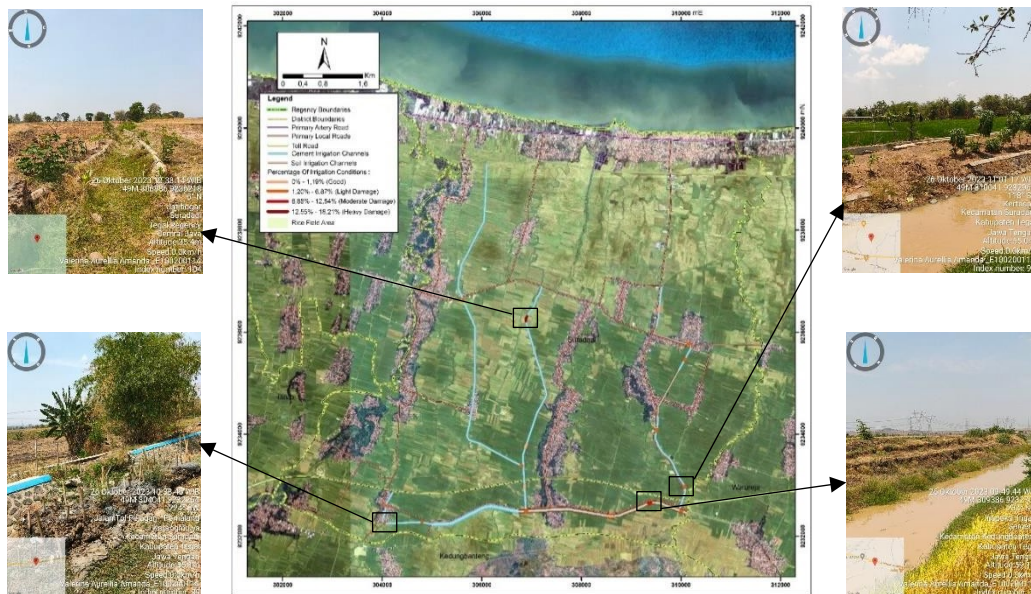
FIGURE 7. Map of Priority Locations For Follow-Up Repair of Irrigation Channels

The analysis is carried out to determine priorities for irrigation repairs by considering the level of damage to the channels and the impacts that may arise due to delays in repairs [21]. After field validation, 4 locations experienced heavy damage as priority follow-up repairs. In addition, the assessment is not limited to the level of physical damage to irrigation channels. By paying attention to the condition of each segment through percentage calculations, only 2 locations were identified that experienced heavy and moderate damage, which were also priorities for follow-up repairs. This shows that priority assessments are not only based on the level of damage but also on locations that have a major influence. The 2 priority locations for improvement follow-up identified from the percentage have the same location as the 4 locations based on the classification of irrigation conditions during validation. So the total number of damage locations that are prioritized for follow-up repairs is 4 locations shown in the black box area in Fig. 7. Improvements are focused on areas that require immediate attention and provide comprehensive solutions to increase irrigation system efficiency. Irrigation channel maintenance is a step to maintain and ensure that irrigation channels always operate optimally, facilitate smooth operational implementation, and maintain the continuity of their function. This is done through a series of actions, such as regular maintenance, repairs, prevention, and security efforts which are carried out on an ongoing basis [22].
